EXHIBIT A

Bishop – Tire Report

I was asked to examine a Dunlop D402 Harley Davidson, serial # DAF4 M17M 3107, rear motorcycle tire (subject tire), and to determine the cause of its failure. My observations and opinions are outlined in the following report. All of these opinions are based on my education, experience, training, skills, knowledge, and a review of the items and documents in this case. All of my opinions are based on a reasonable degree of scientific and engineering certainty.

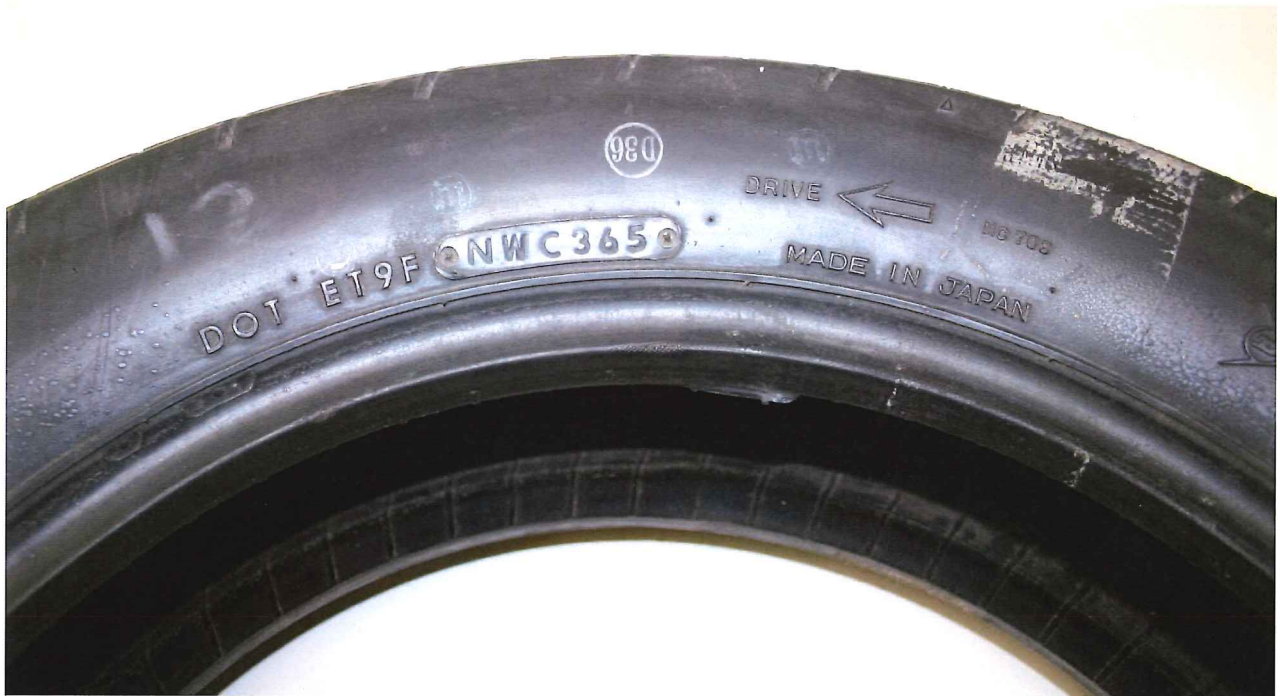
An example of a Dunlop motorcycle tire, made in Japan, showing a total absence of any chafer fabric impressions in the bead rubber is shown in Figure 2.

Figure 2 – “Dunlop Qualifier” 150/90-15 Motorcycle Tire
